# Manhole Inspection Summary

Manhole # S25CC2003MH

Insp Date: **10/31/06 1:23 PM**

**Location** Address: **5510 ROLAND AVE**

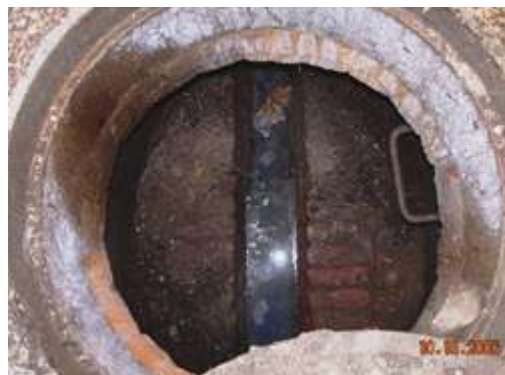
Top View

Evidence of surcharge - Bench debris.  
Channel debris.

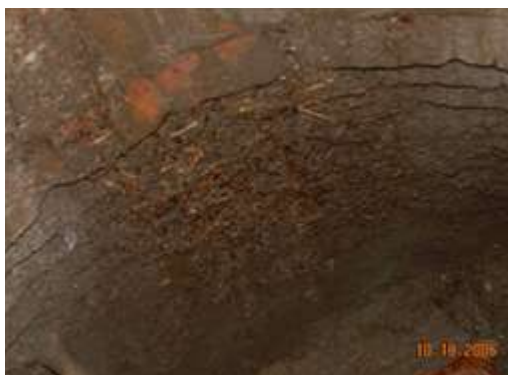
Defect

Adjustment infiltration. Corbel and Barrel  
root intrusion and infiltration.

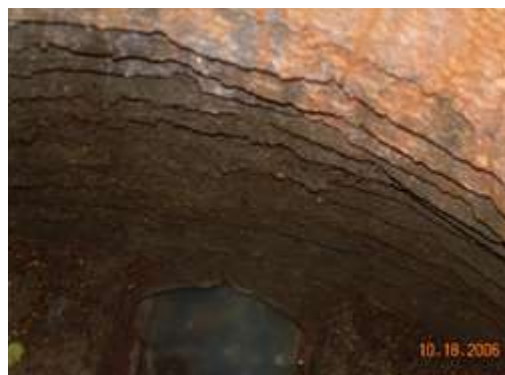
Defect

Adjustment and Corbel infiltration.

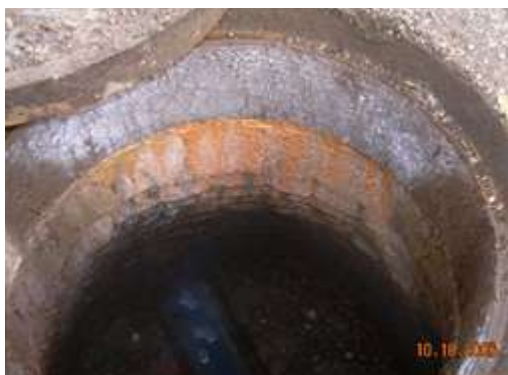
Defect

Frame leaks. Adjustment deterioration  
and infiltration.

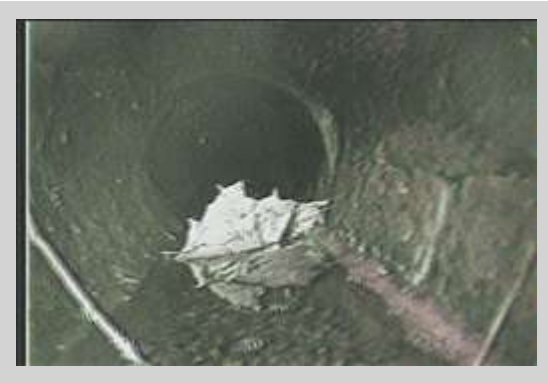
### 8 in. Circular Gravity Sewer Pipe Out @ 12 O'Clock

Deposits: ☐ None ☒ **Mud** ☐ Sludge ☒ **Debris** ☐ Grease

Silt Depth: **0.5** (in.) Deposits Extent: **Light**

Infiltration: **Evidence** Pipe Seal Cond: **Unknown**

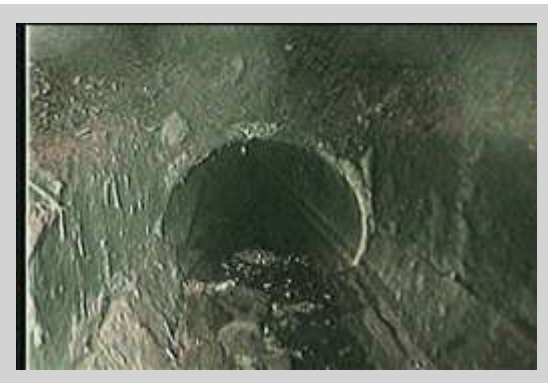
### 8 in. Circular Gravity Sewer Pipe In @ 6 O'Clock

Barrel deterioration and infiltration. Channel deterioration.

Deposits: ☐ None ☒ **Mud** ☐ Sludge ☒ **Debris** ☐ Grease

Silt Depth: **1** (in.) Deposits Extent: **Light**

Infiltration: **Evidence** Pipe Seal Cond: **Unknown**
